Comprehensive Agreement No. 1

Sixth Annual Report

FY19
(July 1, 2018 – June 30, 2019)

Big Chino Sub-basin Water Monitoring Project, July 1, 2018 – June 30, 2019 Annual Report

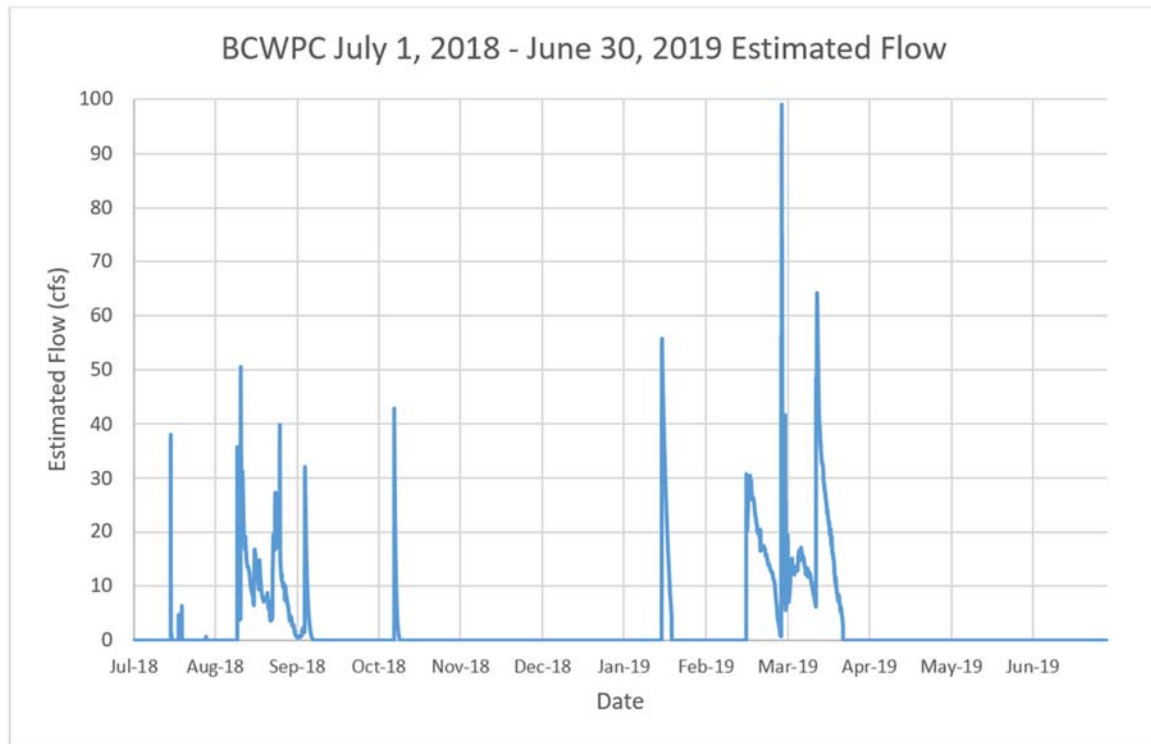
FIGURE 5. BCWPC JULY 2018 – JUNE 2019 ANNUAL FLOW EVENTS

Sixteen (16) events with measurable ephemeral flow were observed at BCWPC during the 2019 annual monitoring period. BCWPC responded to monsoon and winter related precipitation events. Peak discharge for the year was an estimated 99 cfs observed on 3/1/2019. The 2/16/2019 event was the longest lasting event observed at the site for the reporting period with a duration of 313.5 hours, resulting in an estimated total flow volume of 429 AF or 21% of the annual volume at the site. The 3/14/2019 flow event resulted in the largest estimated flow volume at 458 AF or 22% of the annual volume at the site. The total estimated volume recorded at the site for the 2019 reporting period was 2,048 AF. BCWPC flow events, durations, and estimated volumes for the 2019 reporting period are outlined in Table 3 and Figures 5-7.

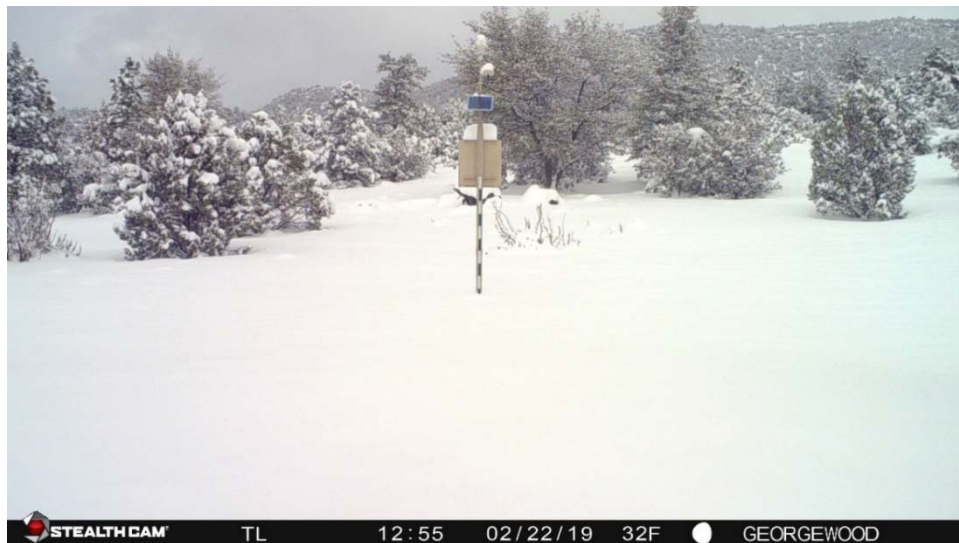
FIGURE 19. GWC IMAGE DATA

Ten (10) snow accumulation events were observed during the 2019 reporting period. For eight (8) of the observed events, snow depth never surpassed 0.1 feet (see Table 5). Two (2) events occurred back-to-back from 2/17/2019 through 2/27/2019. The first lasted three (3) days with a peak snow depth < 0.5 feet. After the snow melted a second, larger storm dropped just under one (1) foot of new snow. The snowpack lasted approximately seven (7) days. On 5/23/2019, a late season storm dropped enough snow to cover most of the ground surface (see Figure 19)

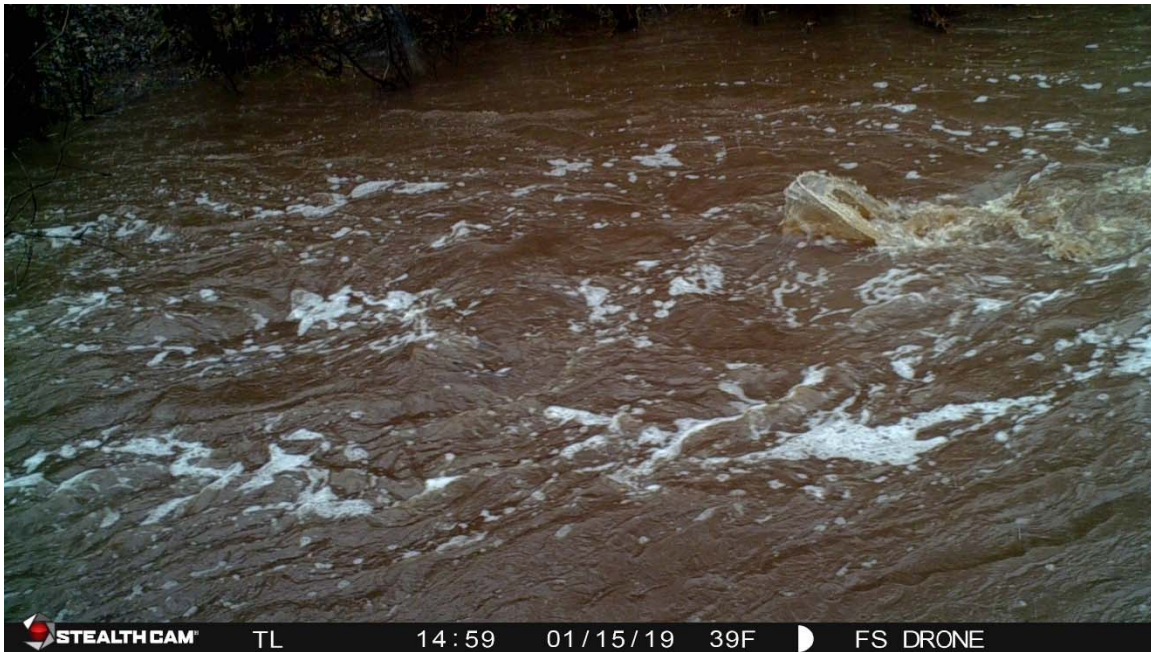
FIGURE 20. UWCFS IMAGE DATA

There are no estimates of flow at this site following the removal of the flume on December 22, 2016, other than visual wet/dry conditions. UWCFS site images are shown in Figure 20 below. UWCFS was dry (the site had no surface flow) from 6/30/2018 through 11/19/2018, with the exception of one monsoon flow event that started on 8/2/2018 at approximately 2:00 p.m., and lasted through the end of the day on 8/4/2018.

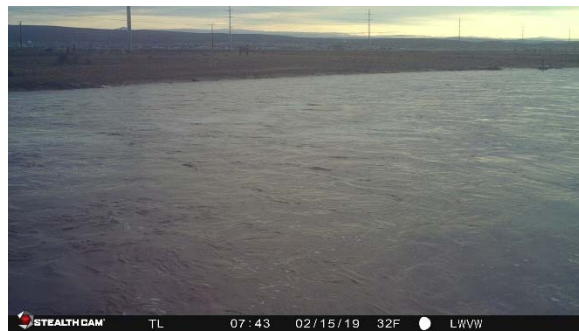
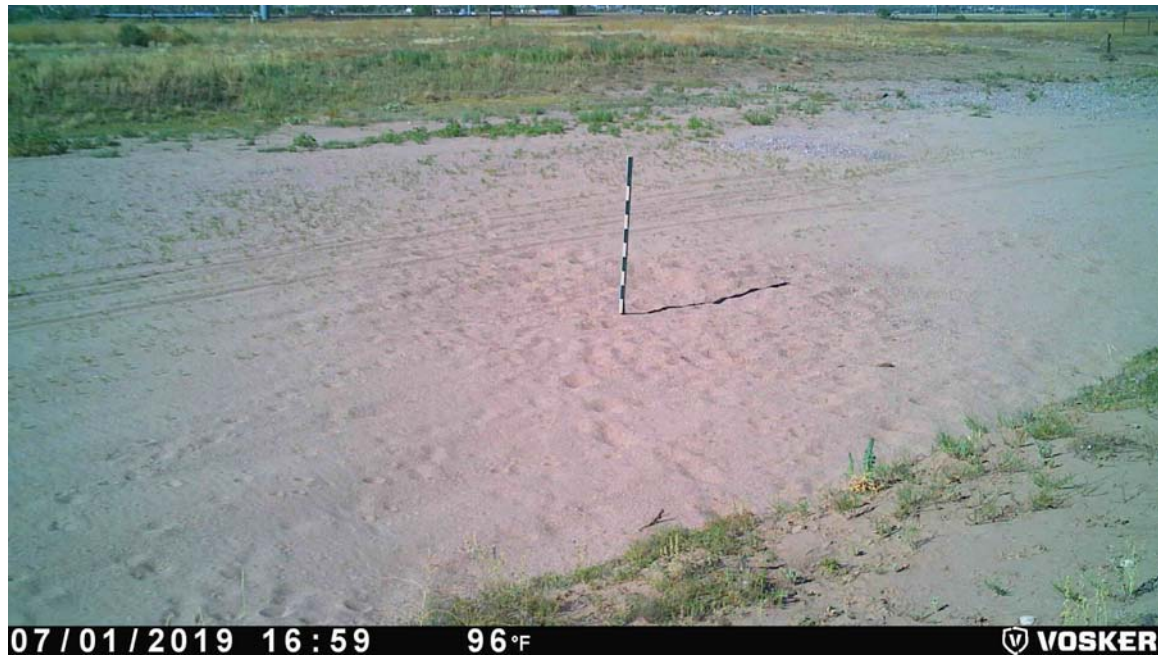
FIGURE 30. LWVW IMAGE DATA

Start of flow event on 2/14/2019:

LWVW on 2/15/2019 with flow above bank full conditions:

- Replaced the downstream event gage and pressure transducer and cable
- Replaced the primary and backup batteries
- Performed current meter measurement during prolonged winter flow
- Upgraded site to 4G camera technology (2G hardware no longer supported by Verizon Wireless)
- Updated camera firmware on primary and backup cameras

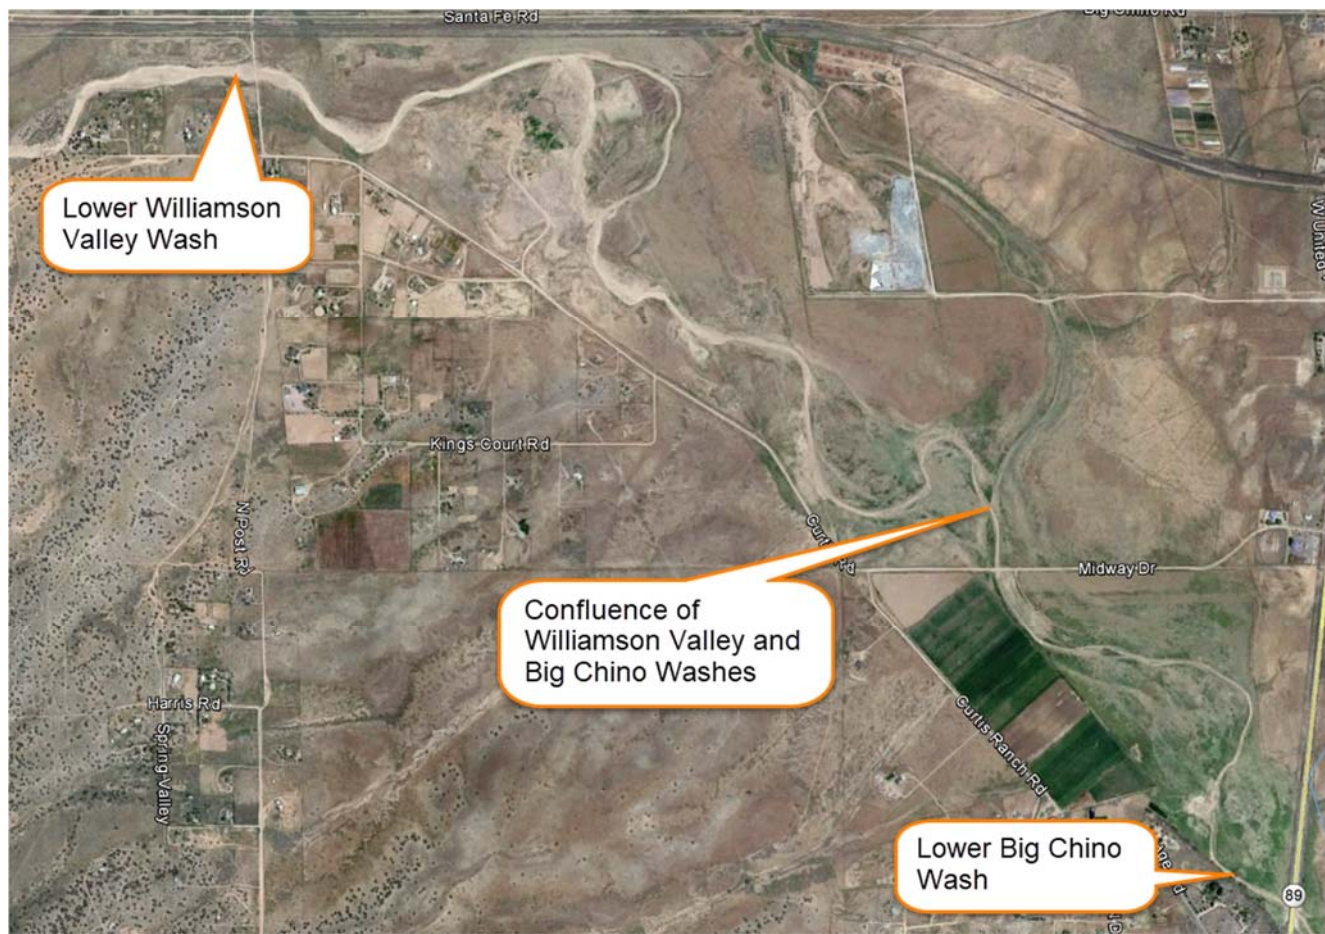
FIGURE 31. AERIAL IMAGE OF WILLIAMSON VALLEY WASH CONFLUENCE WITH BIG CHINO WASH BETWEEN LWVW AND LBCW

The LBCW is located ~ 2.5 miles southeast and ~ 3.8 river miles downstream of LWVW. Between the two sites are a series of meandering bends. The flow relationship between the two sites has behaved as it has in the past several years, where larger accumulated flows were observed at LWVW than at LBCW. The LBCW has a much smaller flow area than at the LWVW, so many times the site experiences flows that exceeds its rating. See Figure 31 below for an aerial image of the sites.

As of this report, the wetted area and its infiltration rate between the the two locations is not defined, see Figure 31. The accumulated flow differences between the two sites are detailed in Figures 32-34 which provide aerial imagery coupled with flow details of three events of magnitude. In addition to the CA1 Monitoring locations, the accumulated flows as defined at the USGS gage sites at Lower Williamson Valley Wash (upstream) and the USGS Big Chino Wash at Paulden, Az gage (downstream of the LBCW) are shown.

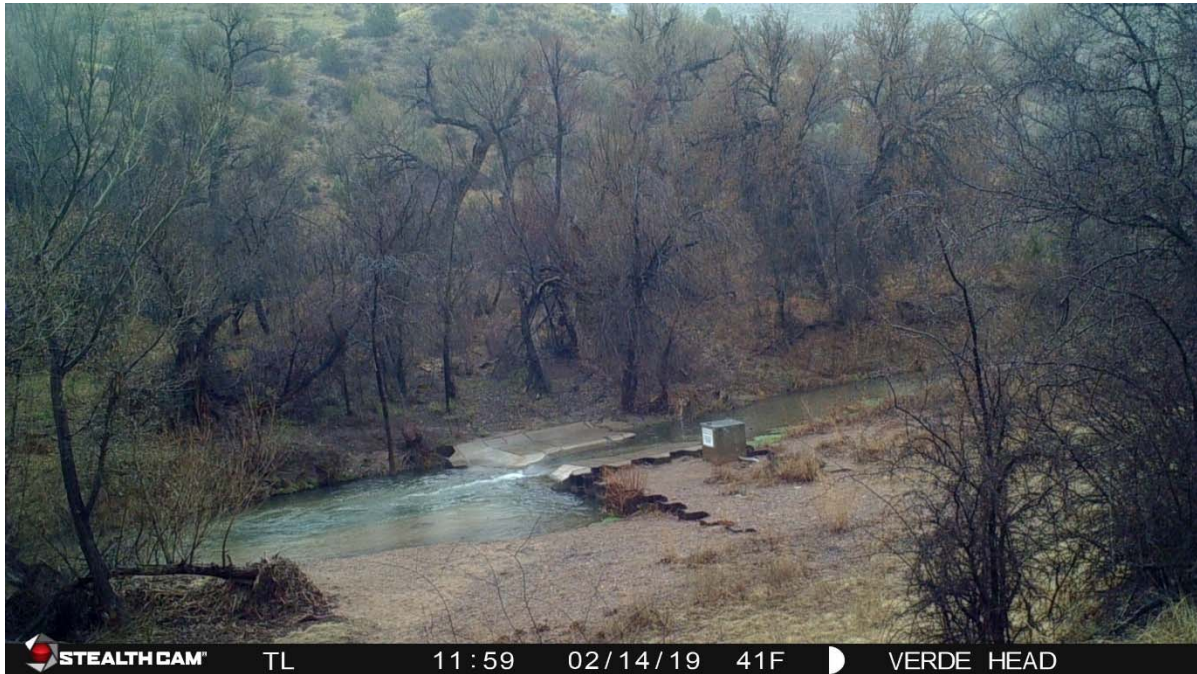
FIGURE 43. VHCR SITE IMAGES

VHCR before flow event on 2/15/2019:

VHCR during flow event on 2/15/2019:
